**DOMINION NUCLEAR CONNECTICUT, INC.**  
**MILLSTONE POWER STATION UNIT 3**  
**LICENSEE EVENT REPORT 2007-002-00**  
**LOSS OF OFFSITE POWER CAUSED BY**  
**TRANSMISSION SYSTEM OPERATOR WHILE DEFUELED**

**LICENSEE EVENT REPORT 2007-002-00**  
**LOSS OF OFFSITE POWER CAUSED BY**  
**TRANSMISSION SYSTEM OPERATOR WHILE DEFUELED**

**Millstone Power Station Unit 3**  
**Dominion Nuclear Connecticut, Inc. (DNC)**

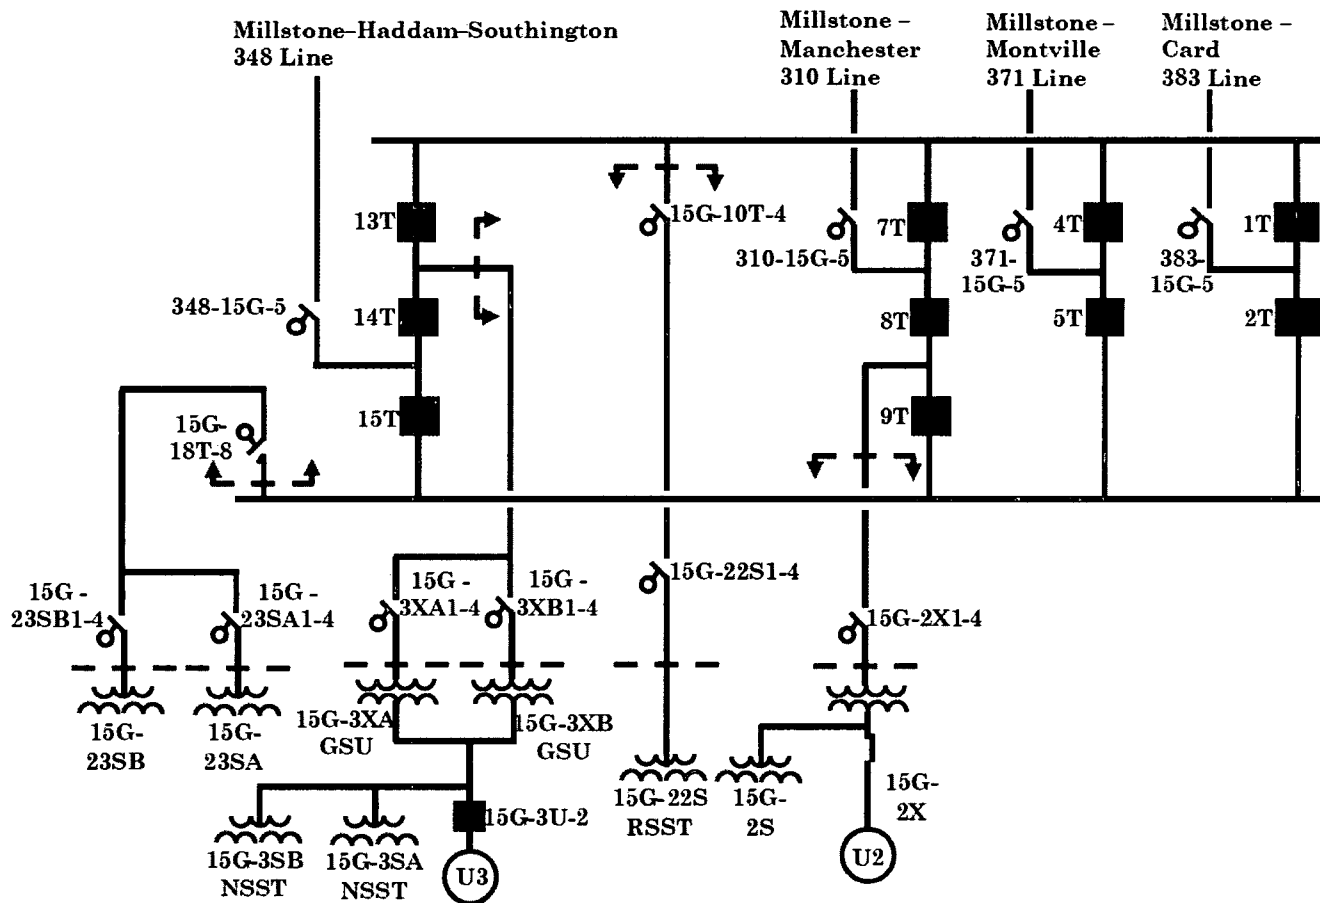
Millstone 15G one-line diagram

The loss of offsite power was caused by a human error on the part of the offsite transmission system operator (TSO). At the time of the event, offsite power to MPS3 was being back-fed via the normal station service transformer (15G-3SA-NSST). The MPS3 reserve station service transformer (15G-23SA-RSST) was removed from service for maintenance. Due to an emergent fault in another portion of the transmission system, one of the offsite supply lines (#348) needed to be removed from service by operations at the offsite TSO at the Connecticut Valley Electric Exchange (CONVEX). This required operation of the Millstone Power Station 15G-14T-2 and 15G-15T-2 switchyard breakers. However, operations at the offsite TSO facility resulted in the 15G-13T-2 breaker being opened instead of the 15G-15T-2 breaker. This error resulted in a LOP to MPS3 (see attached sketch). (During MPS3 operation at power, interlocks exist which would have prevented the offsite TSO from making this switching error.) Based upon a review by the offsite TSO, inadequate self-checking by the offsite TSO System Operations Supervisor prior to breaker manipulation was the apparent cause of this human error.

The offsite TSO has initiated corrective actions to address the human performance aspects of this event. Additional corrective actions at Millstone are being taken in accordance with the station's corrective action program.
